CASE STUDY

RETROFIT
OF AN AMINE FILTER

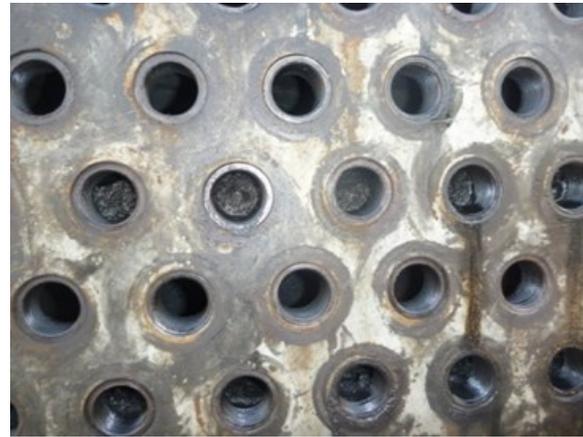
Picture 1: Fouling of cooler tubes

Operational constraints The subject gas plant was suffering from a high solids content in the amine system causing plugging of expander tubes, strippers, absorber trays and piping. The aim of Royal Dahlman's involvement in problem solving was to lower the plant's operational filtration costs and significantly lower the total solids count in the amine system. Before the retrofit of the system, operator personnel were required to carry 7 bags of pre-coat 10 meter upstairs to add this into the mixer. This could potentially cause personal injuries. The existing pre-coat plate and frame type filters were not performing well and as a result the excessive solids contamination was causing major fouling of the cooler tubes as shown in Picture 1. This severely impacted the heat transfer and capacity of the plant. On Picture 2 the fouled plate and frames (internals of the pre-coat filter with the metallic mesh filters) are shown. The plates were found to be plugged for at least 25% of their total surface area with pre-coat material. This was causing lower throughput over the filters and a rapidly increasing pressure drop. As a result, high TSS contaminants in the DEA caused corrosion, erosion, wear and tear of process equipment in the plant. Overall the plant was suffering from bad performance, partly caused by the malfunctioning filters.

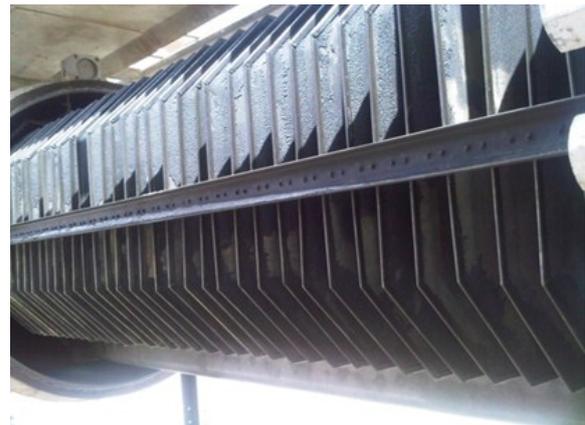
Picture 2: Plate & Frames partly "plugged" with pre-coat

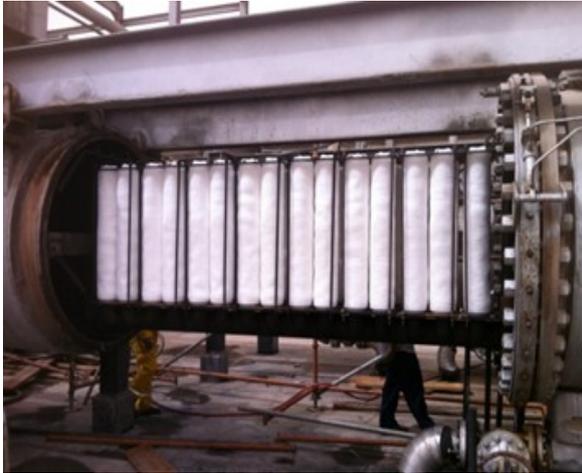
Picture 3: Retrofitted pre-coat filter to cartridges

The improvement After the investigation of these operational problems Royal Dahlman designed and proposed a "new", and improved, filter system that could be installed directly into the existing pre-coat filter, with no welding required to the existing vessel. The Royal Dahlman cartridge filters had demonstrated to be able to reduce the TSS level significantly.

As a result, it was concluded that retrofitting the pre-coat filter to make use of the Royal Dahlman High Flow High Solids cartridge filter system was a sound technological and commercial improvement, please refer to Picture 3, to see how the unit was retrofitted. With this retrofit, equipment reliability

The operation of one pre-coat filter required roughly 6-10 hours of slurry preparation for each filtration cycle. After the retrofit, the use of mixers, pumps (and related maintenance), demineralized water and related costs have been eliminated. The operator involvement (for replacing the filter cartridges) has been reduced to a mere 2 hours, instead of the previously required 6-10 hours.

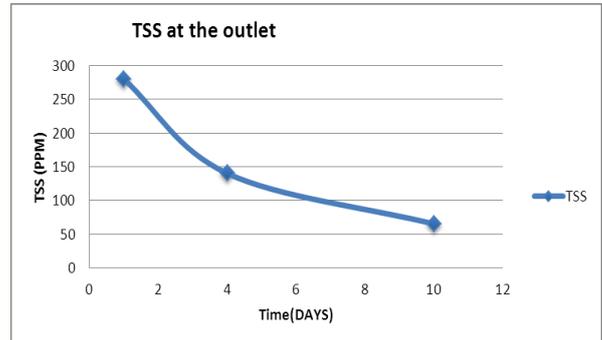
Above you see the graph of the DEA quality showing the TSS value after starting the cartridge filter system. During the operation of the pre-coat system, TSS values continuously spiked above 250ppm. Note that due to the large volume of particles still remaining within the system, element change-out was carried out twice within the first month. With each change-out of the elements, over 100kg of solids has been removed from the system.

DEA quality The quality of DEA (such as TSS, color, etc.) became excellent after the cartridge filters were installed. This further improved and extended the life and usability of the DEA while improving the absorption capacity of acid gases due to the highly pure solution. As a result, the filter lifetime of the filter cartridges further improved. Below you can see two different samples of the amine. The sample on the left was taken from the outlet of the pre-coat filter and on the right the amine from the outlet of the cartridge filter. Their differences speak volumes.
